Amery Lakes Aquatic Plant Management Plan

Pike, North Twin, and South Twin Lakes

Polk County, Wisconsin

DRAFT PLAN

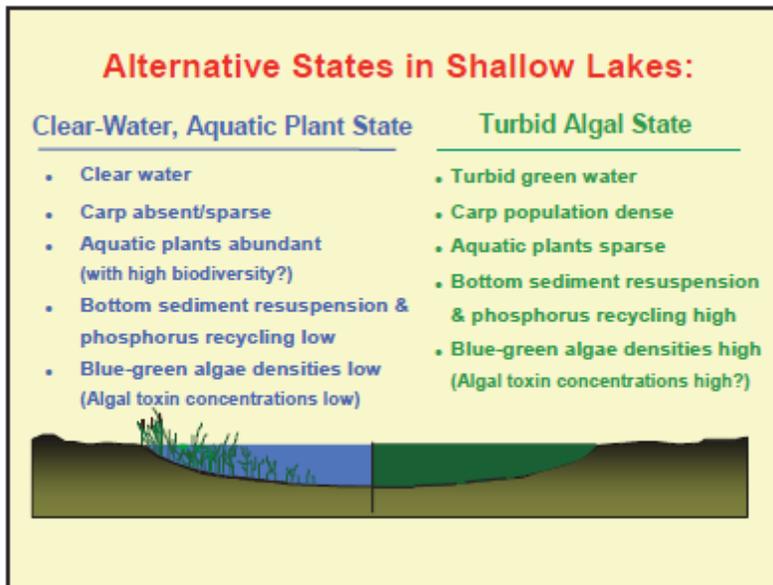
Figure 2. Alternative States in Shallow Lakes

It is important to note that aquatic plants play a critical role in maintaining water quality in the Amery Lakes – especially in South Twin, because it is very shallow. If aquatic plants are not present in shallow lakes, nutrient-rich sediments can be re-suspended, and water clarity would be expected to decrease dramatically. The figure below illustrates that for shallow-water lakes, an aquatic plant dominated system is highly preferable to a lake without aquatic plants. In fact, restoration efforts for shallow lakes frequently focus on re-establishing aquatic plants in order to improve water clarity.

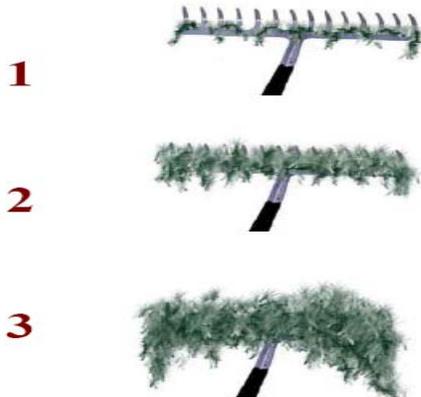
Figure 3. Plant Rake Fullness

Rake Fullness Rating	Criteria for Rake Fullness Rating
1	Plant present, occupies less than ½ of tine space
2	Plant present, occupies more than ½ tine space
3	Plant present, occupies all or more than tine space
v	Plant not sampled but observed within 6 feet of boat

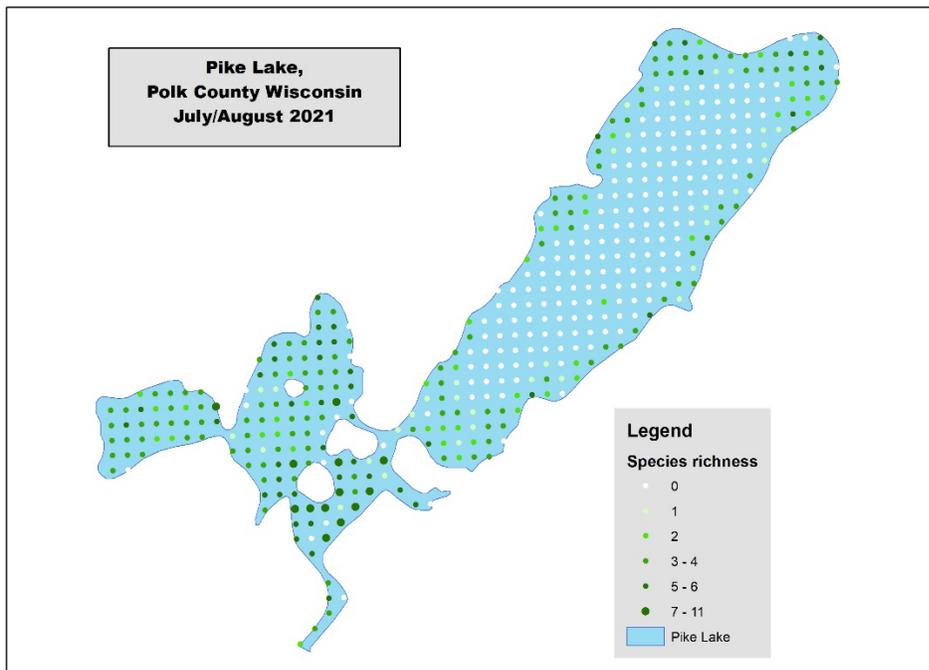
Figure 5. Pike Lake Species Richness (2021)

The southwestern portion of Pike Lake, commonly referred to as the “Bass Hole,” has widespread coverage of dense plant growth. It is also the region where most of the plant diversity and species richness occurs. The plants in this area provide an exceptional aquatic plant community for Pike Lake, with excellent habitat for fish, birds, reptiles, amphibians, and mammals. Protection of the aquatic plant community of this area is paramount to maintain habitat diversity.

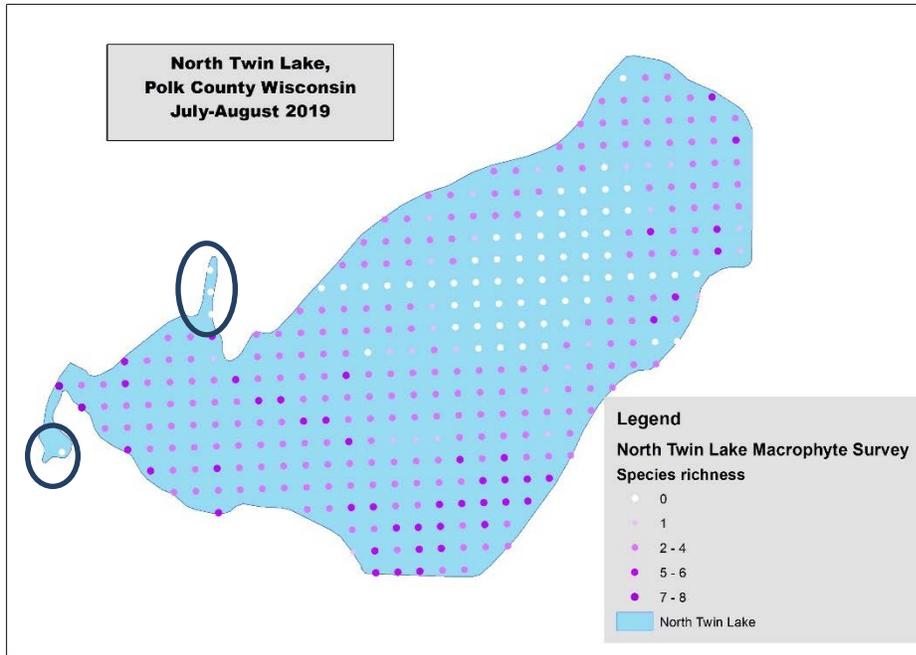
Figure 7. North Twin Lake Species Richness (2019)

The locations with the highest number of species per point occurred in the southern bay and the west bay near the narrows coming in from Pike Lake. The circled areas in Figure 7 were not navigable (and therefore, not sampled) but did have extensive plant growth.

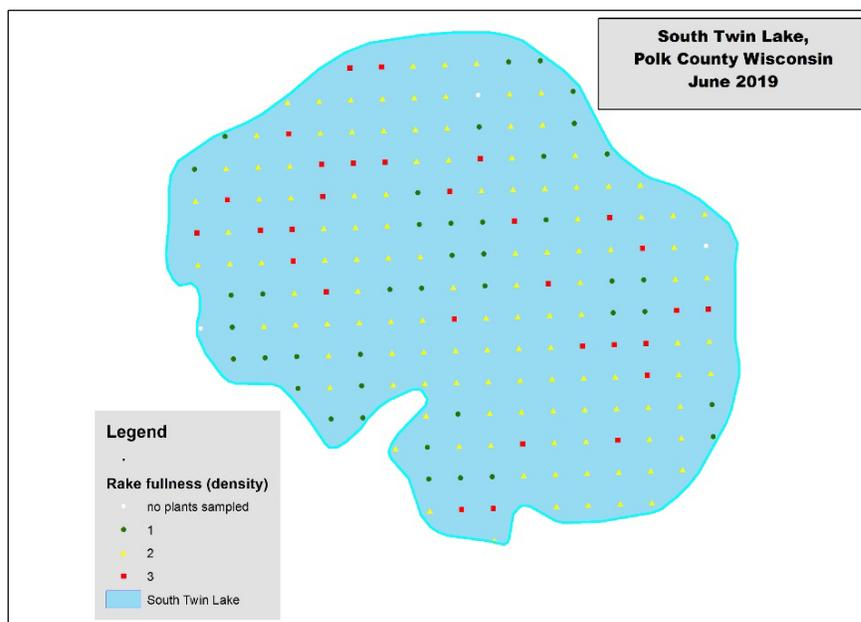
Figure 8. South Twin Lake Rake Fullness (2019)

Aquatic plant growth is widespread in South Twin Lake with no particular regions of the lake that had more plant coverage or more diversity. The most common plant sampled in South Twin Lake was fern pondweed, with a relative frequency of 24.5. This demonstrates that fern pondweed dominated the lake: 1 in 4 plants sampled was fern pondweed. This desirable plant has a high conservatism value of 8, which indicates a healthy plant community.

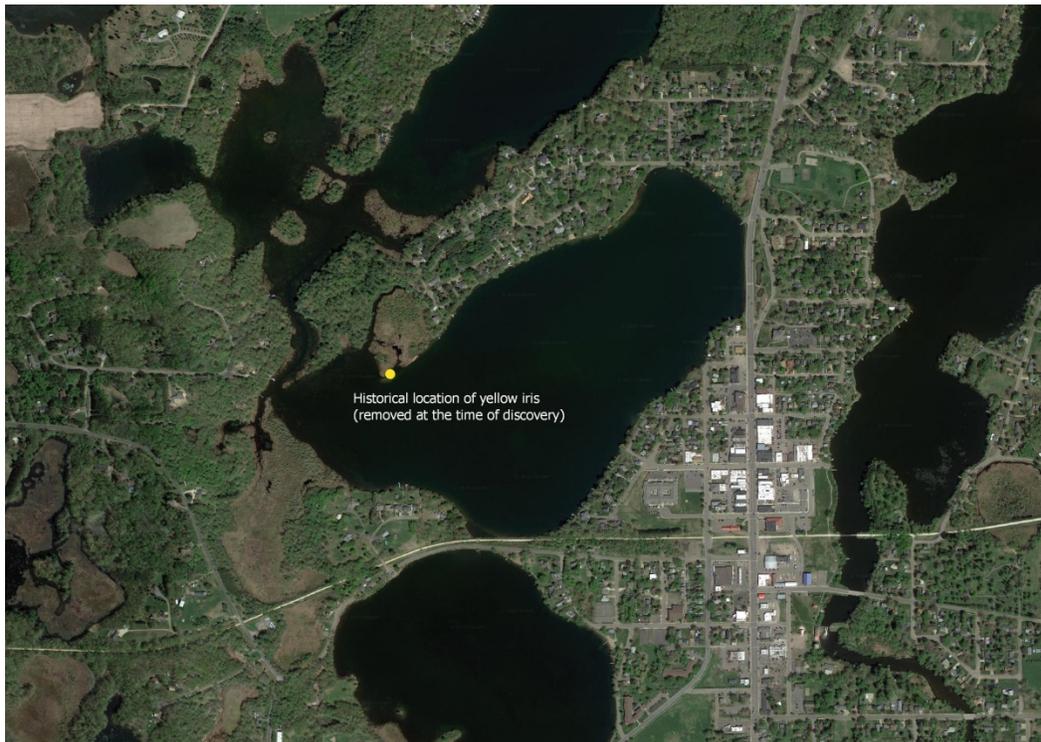
Figure 10. Former South Twin Lake Yellow Iris Location

Yellow iris was identified in a wetland along South Twin Lake and removed around 2018. No current locations of yellow iris plants are known on Amery lakes.

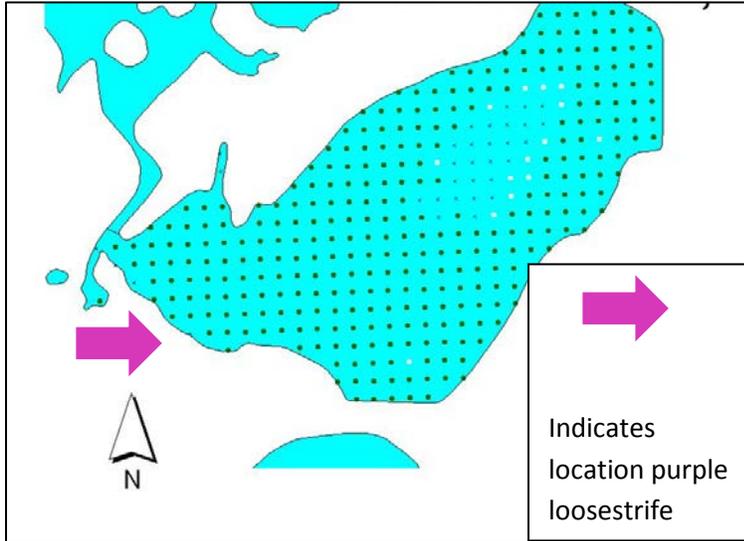
Figure 11. North Twin Lake Purple Loosestrife Observed

Purple loosestrife was observed on North Twin Lake in the 2012 survey as shown in Figure 11. At that time, a few plants were seen growing along the bog area along the western shore. These plants were removed. A similar number of purple loosestrife plants were found in this same area around 2004 and were removed.¹² Purple loosestrife has also been observed on South Twin Lake. Purple loosestrife can spread rapidly, and therefore should be monitored carefully in this important bog habitat.

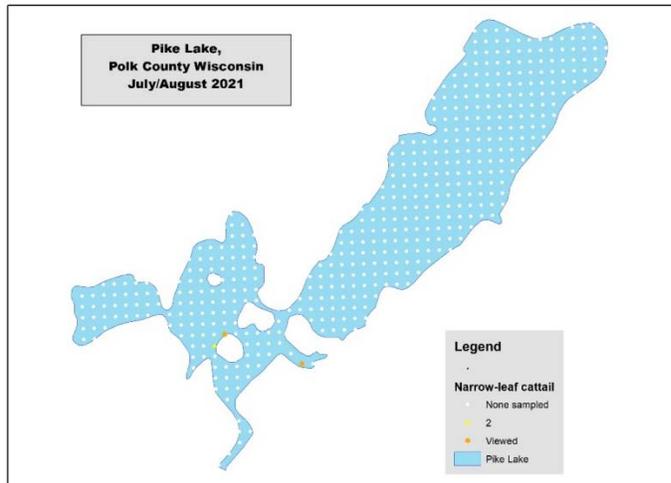
Figure 13. Pike Lake Narrow-leaved Cattail (2021)

Narrow-leaved cattail is an introduced species and according to the Wisconsin DNR, is potentially invasive.¹³ Some literature suggests that narrow-leaved cattail does not act invasively when competing with broad leaf cattail. It can tend to be more common than broad-leaf cattail because narrow-leaved cattail is tolerant of deeper water. One study suggests that in more shallow water, which broad-leaf cattail prefers, the narrow-leaf cattail remained the same or declined slightly.¹⁴ Narrow-leaved cattail can also hybridize with broad leaf cattail, and this hybrid tends to spread more quickly than narrow-leaved cattail.

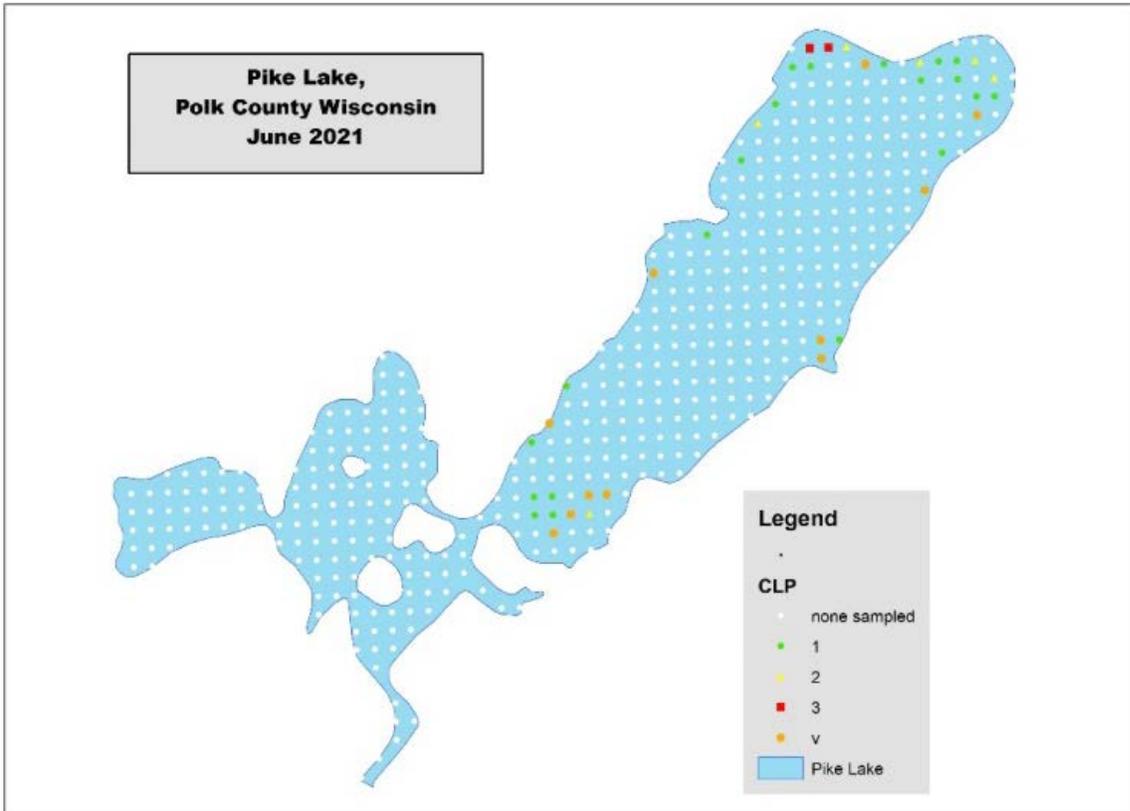
Figure 15. Pike Lake CLP Rake Fullness (2021)

Curly leaf pondweed (CLP) has not grown to nuisance levels in project lakes. In Pike Lake, it tends to grow in clumps rather than in large, dense beds. Curly leaf pondweed was sampled in Pike Lake in both the June 2012 and June 2021 point intercept surveys. Most was found on the northeast end of the lake (Ecological Integrity Service and Harmony Environmental, 2014) (Schieffer, Amery Lakes Aquatic Plant Survey Results, 2021).

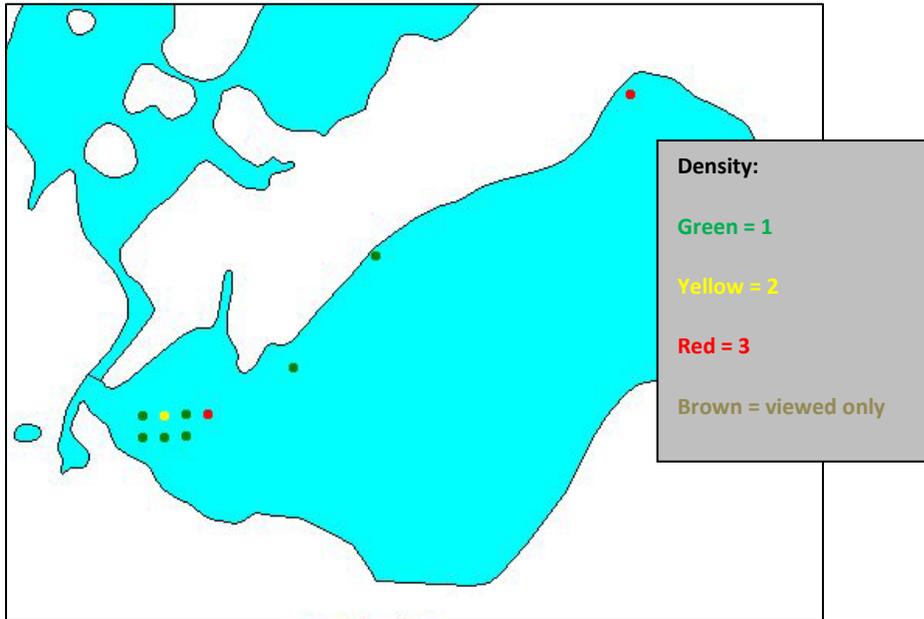
Figure 16. North Twin Lake Curly Leaf Pondweed Distribution (June 2012)

CLP was sampled in 12 locations in North Twin Lake in June 2012. At that time there were small CLP beds in the northeast and southeast bays. CLP was also present in the west basin near the narrows where CLP growth was scattered with a wide range of density (Ecological Integrity Service and Harmony Environmental, 2014). Curly leaf pondweed was not found in the 2019 aquatic plant survey, but it is not expected in July and August when the survey was conducted. Curly-leaf pondweed was sampled on South Twin Lake in June 2019.

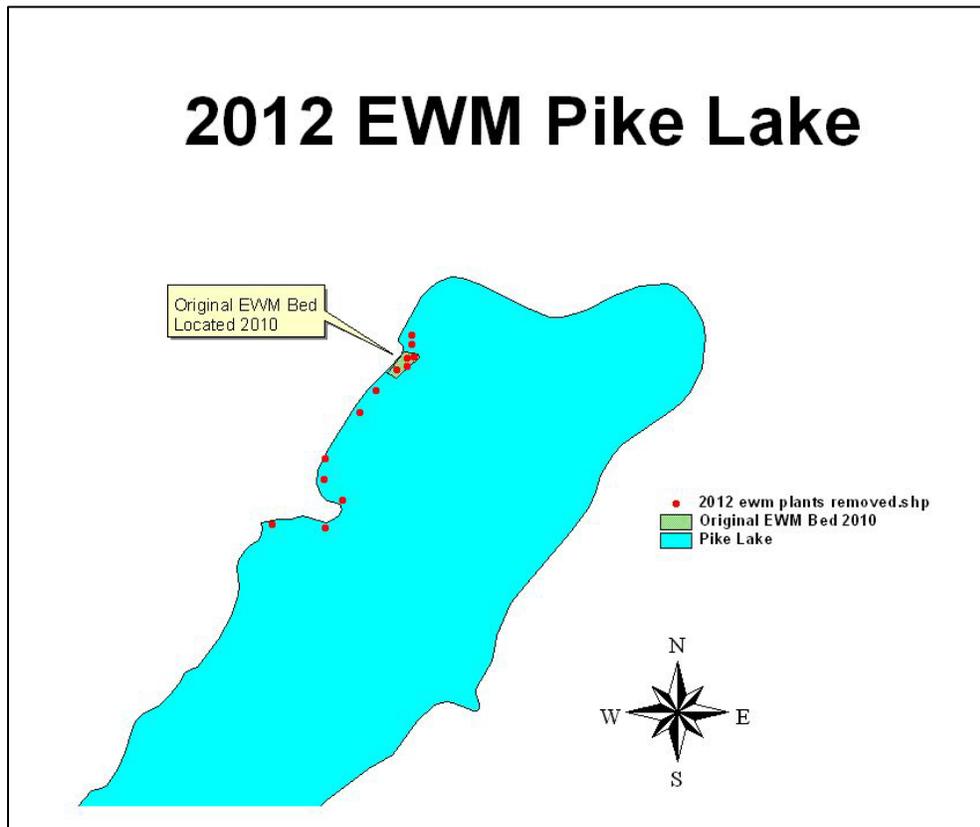
Figure 18. Pike Lake Eurasian Water Milfoil Distribution (2012)

When EWM was found near the original treatment area and along the northwest shoreline during subsequent monitoring in 2010-2013, it was hand-pulled by divers. Figure 18 shows the locations of EWM during the point intercept survey of 2012 and the original 2010 treatment area.

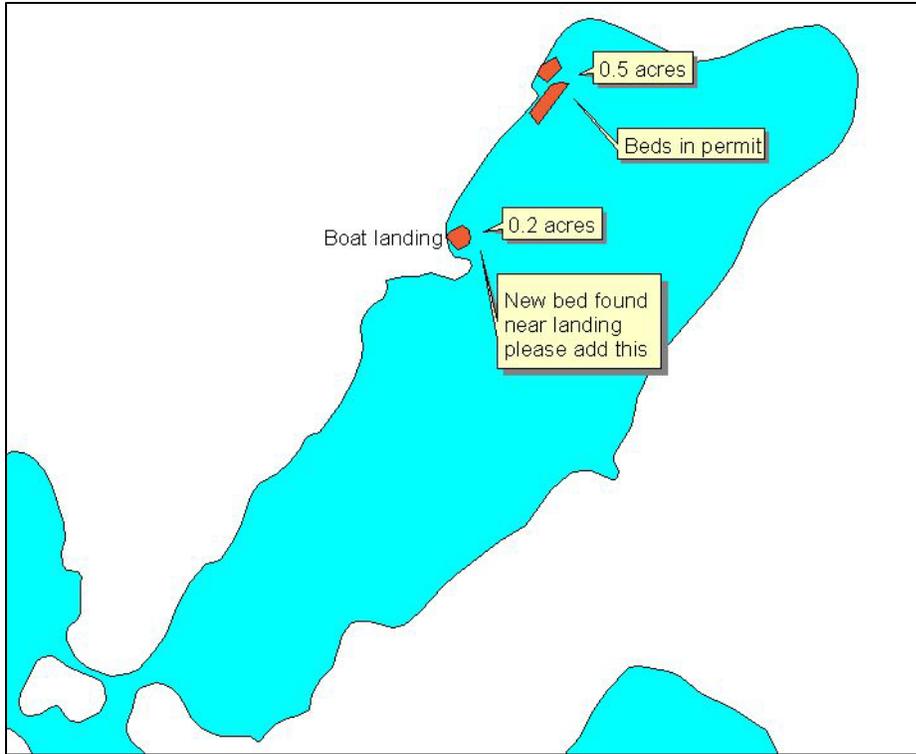
Figure 20. Pike Lake Eurasian Water Milfoil Treatment Beds (2013)

EWM control efforts are summarized in Table 27. EWM became dense enough to warrant herbicide treatment again in Pike Lake 2013. Figure 20 shows the areas delineated and treated. In 2013 the pretreatment frequency of EWM in treatment beds was 84%. Following treatment, the EWM frequency was 8%. Subsequent 2,4-D herbicide treatments of less than one acre each year occurred on Pike Lake in 2015 and 2016 with good short-term results. A trial of Diver Assisted Suction Harvesting (DASH) in 2017 and 2018 resulted in reduced density of EWM, but it did not reduce the presence of the plant.

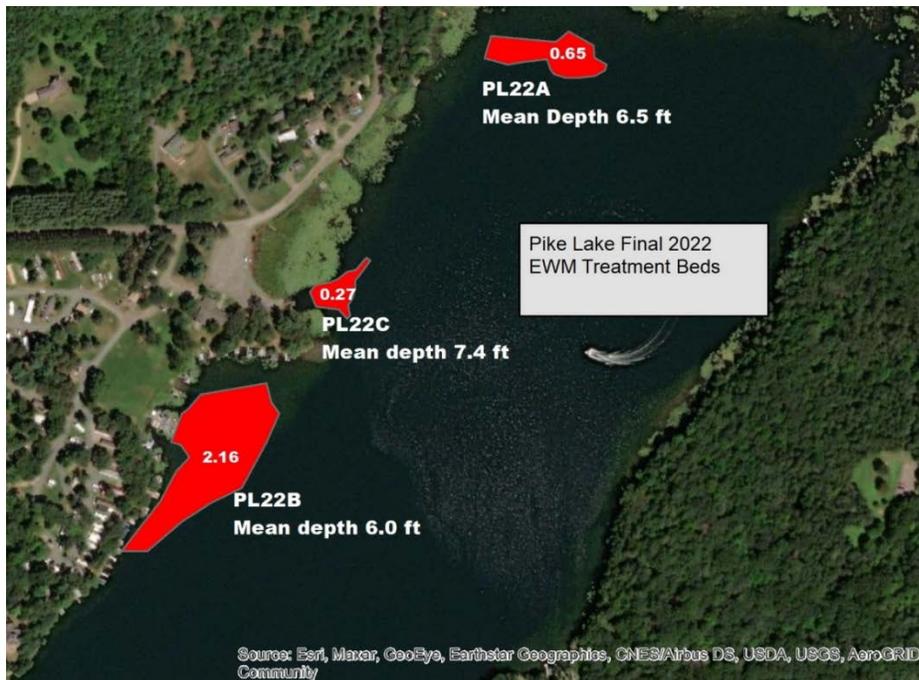
Figure 21. Pike Lake Eurasian Water Milfoil Treatment Beds (2022)

On June 15, 2022, the herbicide ProcellaCOR was again used to mitigate growth of 3.08 acres of EWM in three beds in Pike Lake. Detailed treatment results are included in Appendix B (Schieffer, 2022). The frequency of the EWM went from 90% to 0%, and there were no new beds and only a few individual plants observed in September 2022 on Pike Lake.

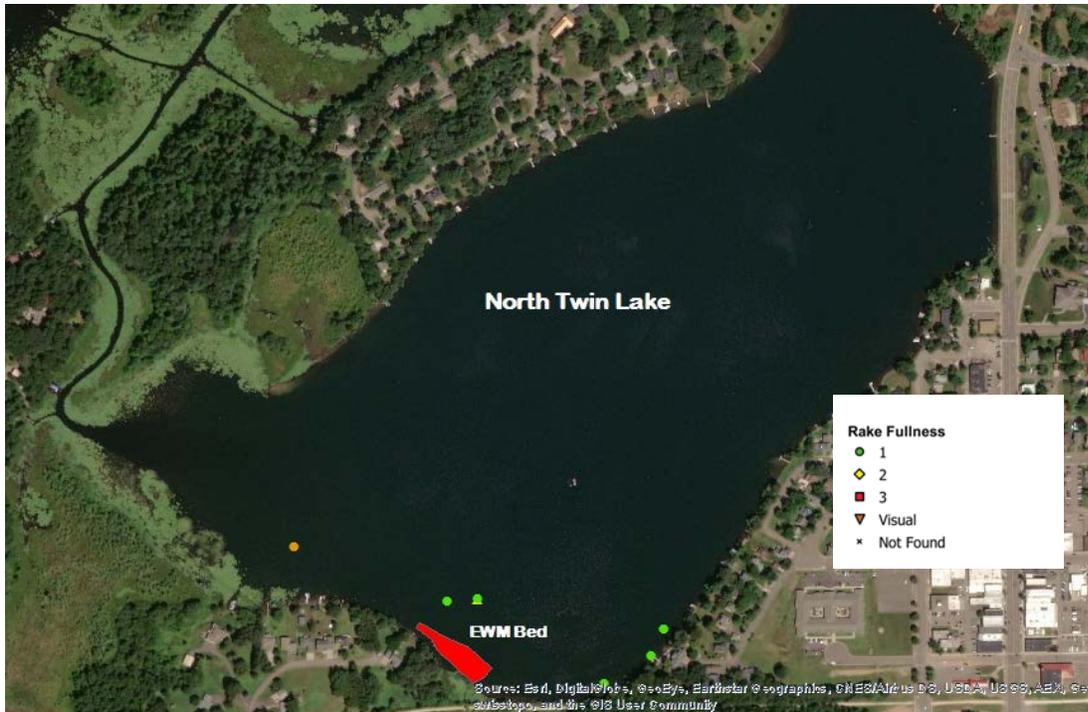
Figure 22. North Twin Lake EWM June 2019 Treatment Bed and August 2019 Locations

Eurasian water milfoil was discovered in North Twin Lake in 2018 and treated with herbicide in June 2019. The herbicide ProcellaCOR (Florpyrauxifen-benzyl) targeted one EWM bed totaling 0.56 acres (shown in red in Figure 21). The frequency of occurrence of EWM in the bed prior to treatment was 100%, and it was 0% after treatment. There was no significant reduction in native species following herbicide treatment. A meander and point intercept survey of the entire lake (in August 2019 following the herbicide treatment) found individual plants or very small clumps of EWM in six locations, all in fairly close proximity to the treatment bed (Schieffer, 2019).

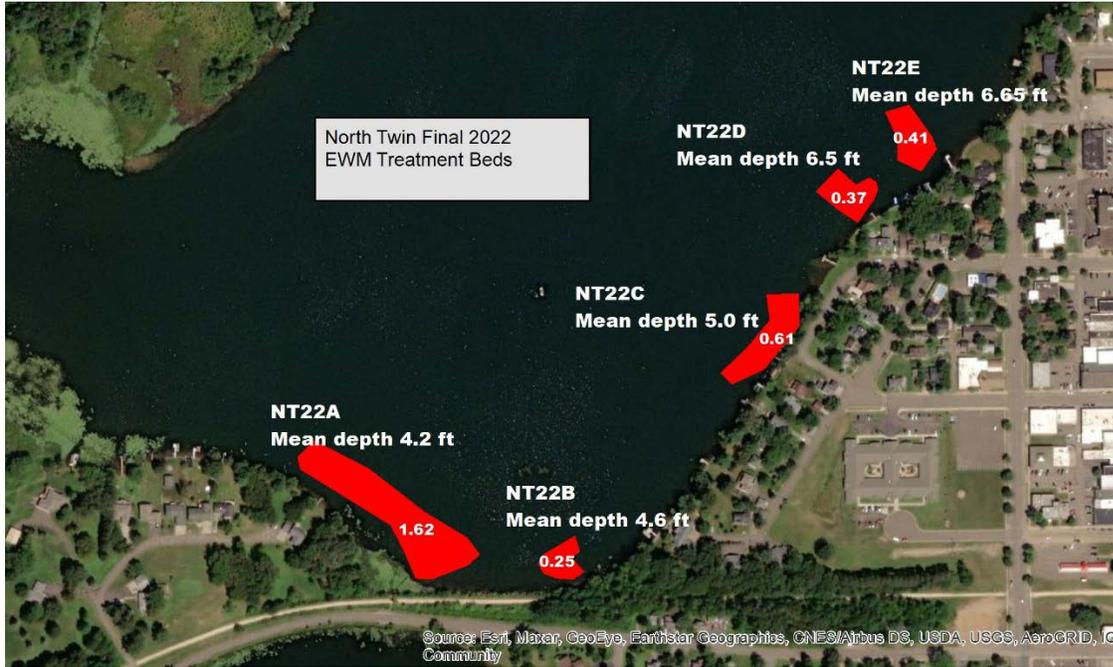
Figure 23. North Twin EWM Treatment Beds (2022)

On June 15, 2022, the herbicide ProcellaCOR was applied to five beds of Eurasian watermilfoil (EWM) totaling 3.26 acres on North Twin Lake. Detailed treatment results are included in Appendix C (Schieffer, 2022). The herbicide treatment resulted in no EWM sampled within the treatment beds in August 2022. There were no statistically significant reductions in native plants between August 2021 and August 2022 following the June 2022 herbicide treatment.

There were no beds of EWM remaining in September 2022 on North Twin Lake. Therefore, there should be no need for herbicide treatment in 2023. Monitoring will continue as there were a few single plants viewed in new areas of the lake. These could expand into beds in the future (Schieffer, 2022).

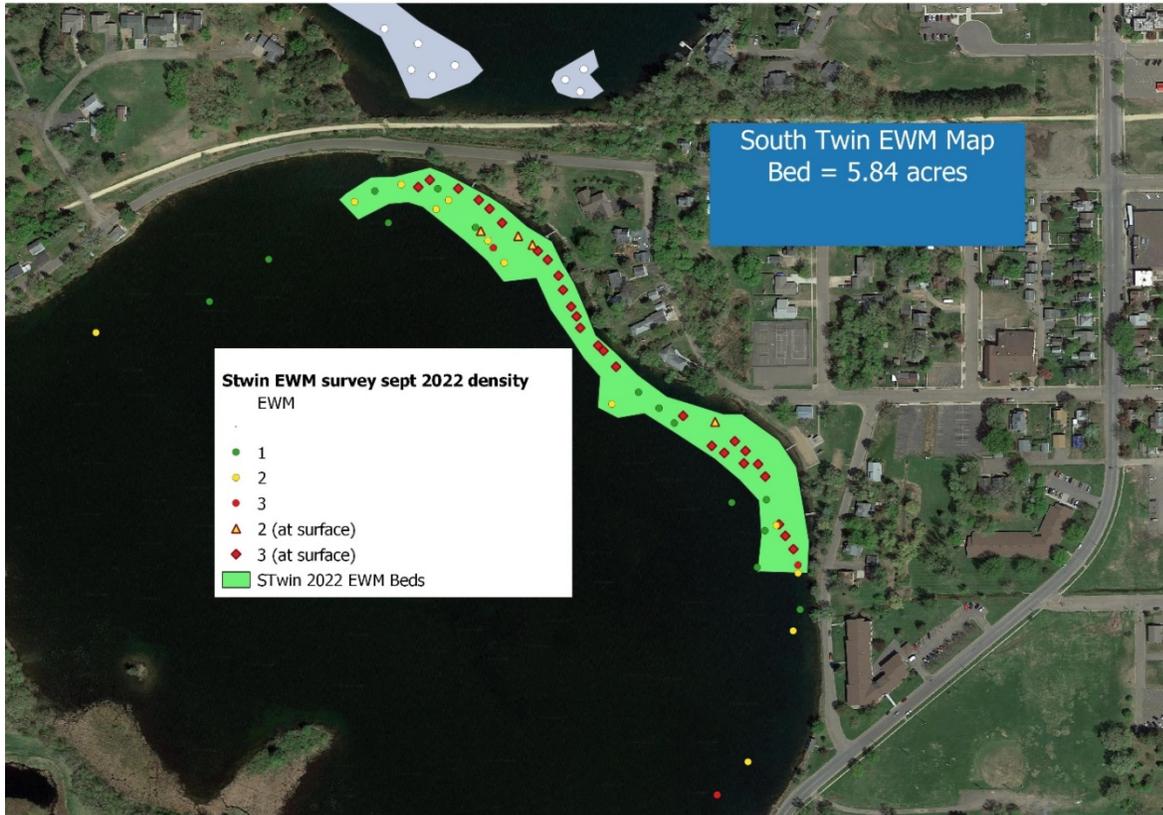
Figure 24. South Twin Lake EWM Survey (2022)

When the lake was surveyed for EWM on September 2, 2022, there were 5.84 acres of EWM found growing in a concentrated bed (Figure 24). Some points within the bed were not sampled to avoid EWM disturbance and spread. The identified bed would allow for good coverage should herbicide be used to mitigate the EWM. If herbicide is applied, the map will be updated before herbicide application. Some EWM clumps/individual plants observed outside the delineated bed would not warrant herbicide application because of low density EWM growth (Schieffer, 2022).

Eurasian water milfoil (EWM) was observed in South Twin Lake in a 2019 AIS meander survey, but was not sampled on the rake or viewed within six feet of any sample points in the 2019 point intercept survey. Growth has expanded, and a 5.84 acre bed was identified in 2022 for potential treatment in 2023.

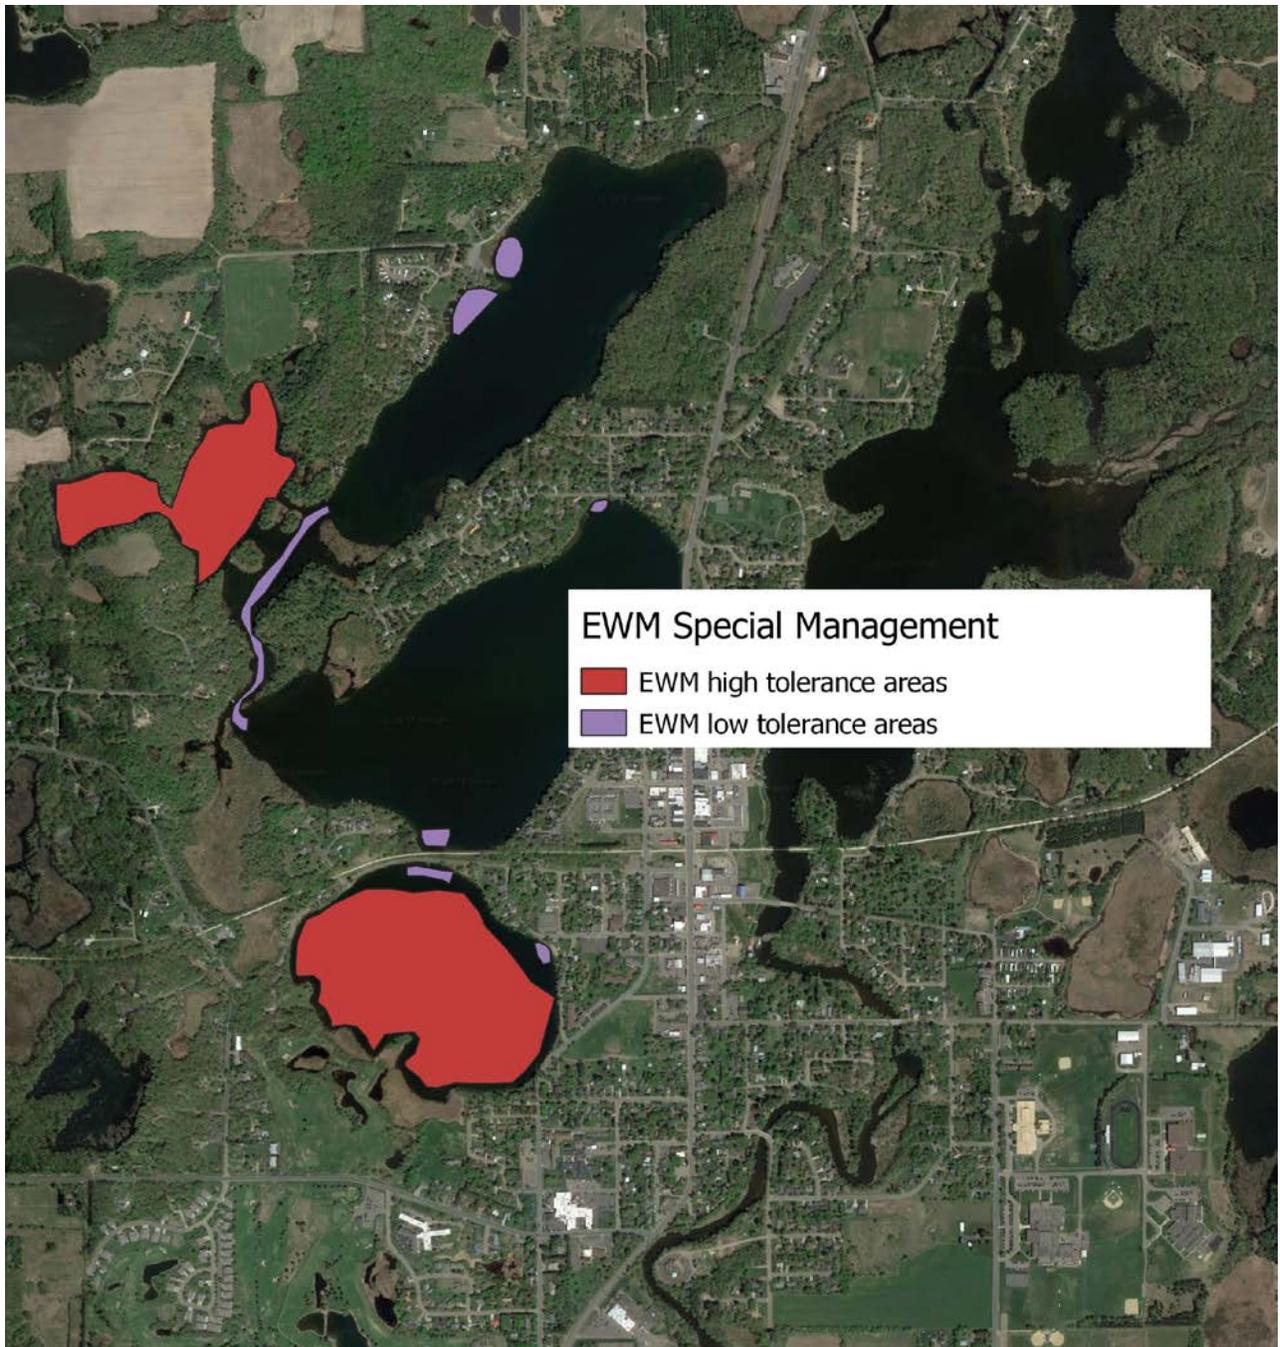
Figure 25. Low-tolerance and High-tolerance Eurasian Water Milfoil Areas

High-tolerance areas: South Twin and Bass Hole

- Minimum treatment total area per lake = 5 acres
- Minimum individual bed size of dense EWM growth = 1 acre

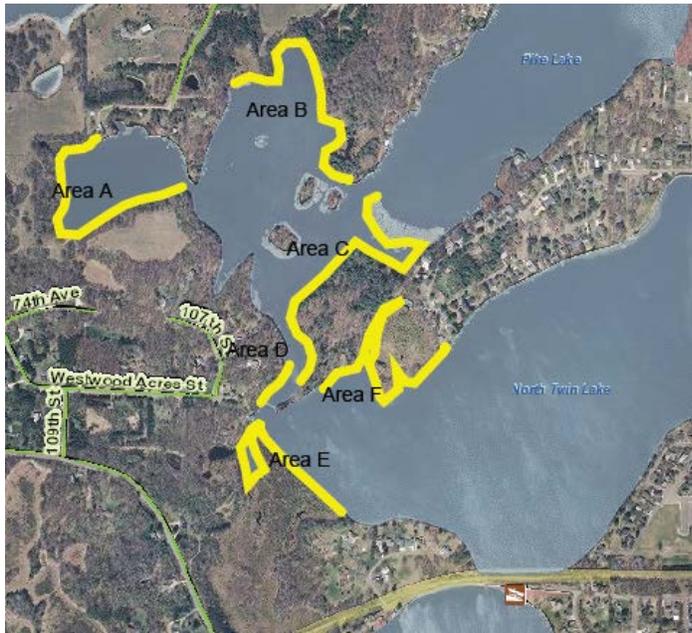
Figure 27. Proposed Critical Habitat Areas A-F

The map below shows the areas that were considered critical habitat areas for Pike Lake, North Twin Lake, and South Twin Lake. The areas were selected because they provide benefits for fish, birds, mammals, and/or protect water quality, and/or are critical to the lake ecosystem health. These areas have not been formally adopted by the Department of Natural Resources.

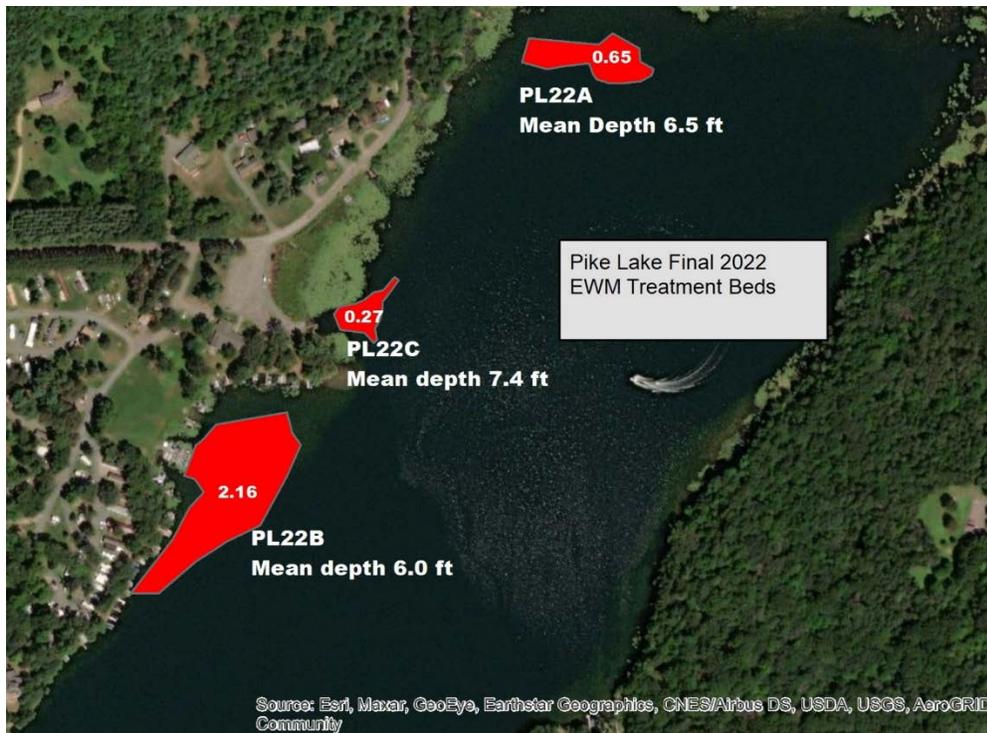
Bed	Area (acres)	Mean Depth (feet)	Acre-feet	Water Temp	Wind	ProcellaCOR Dose
PL22A	0.65	6.5	4.23	72	0-3/NW	5 pdu/acre-foot
PL22B	2.16	6.0	12.96	72	0-3/NW	4 pdu/acre-foot
PL22C	0.29	7.4	2.00	72	0-3/NW	5 pdu/acre foot

The map below shows the locations and sizes of the various treatment beds.

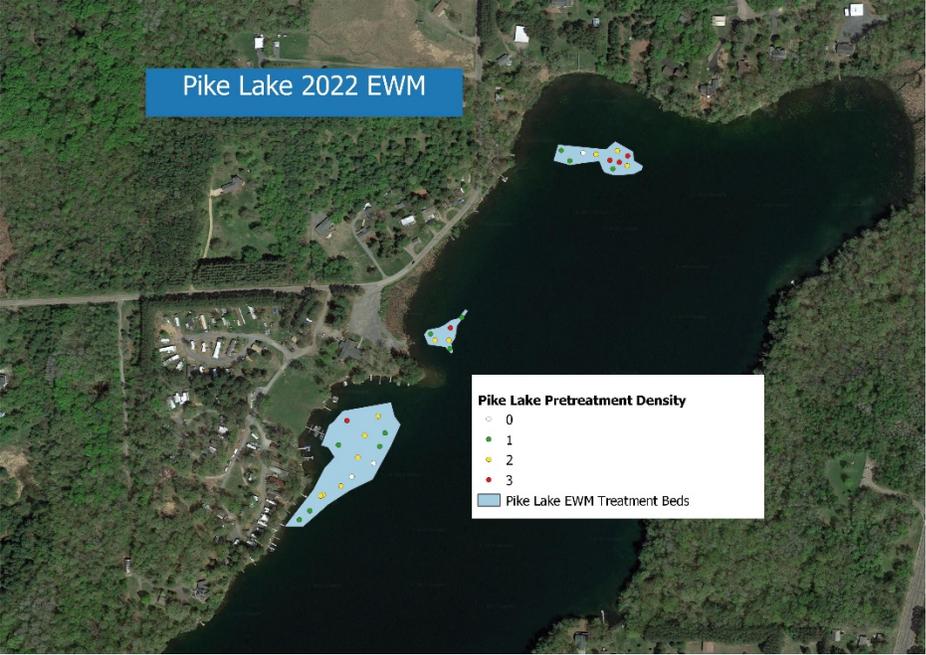
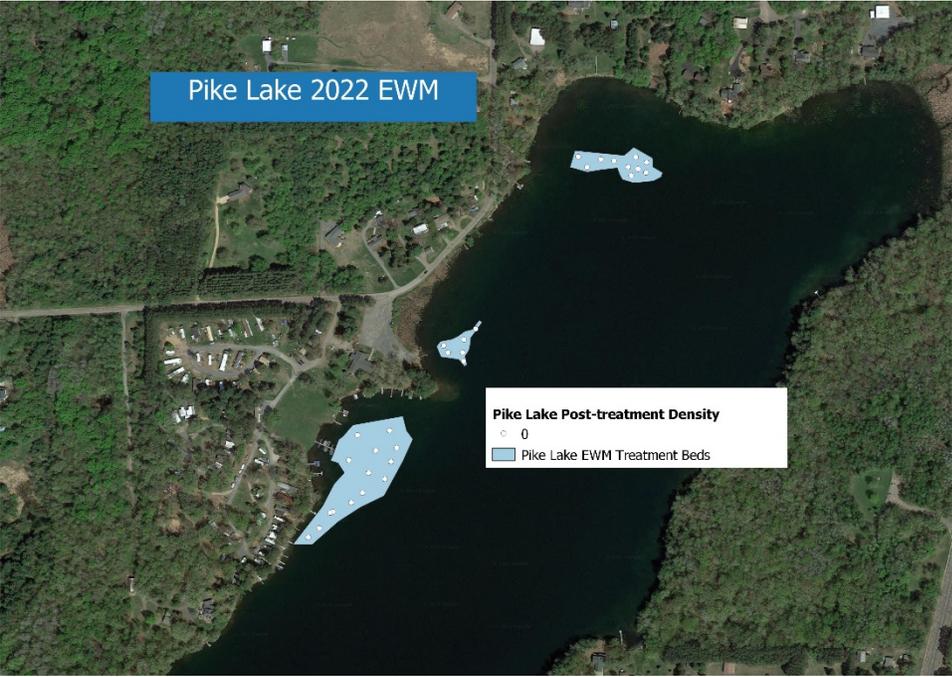
Bed	Pretreatment frequency	Post-treatment frequency	Change/significant?	P-value (from chi-square)
PL22A	90.0%	0%	Decrease/yes	5.0×10^{-5}
PL22B	85.7%	0%	Decrease/yes	6.1×10^{-7}
PL22C	100.0%	0%	Decrease/yes	5.3×10^{-4}
All beds combined	90.0%	0%	Decrease/yes	2.4×10^{-12}

The following maps show the rake fullness of EWM within each treatment bed. The first map is before treatment (August 2021), and the second is after treatment (August 2022).

The June 2022 treatment using ProcellaCOR on three beds of EWM in Pike Lake reduced the targeted EWM. The frequency of the EWM went from 90% to 0%.

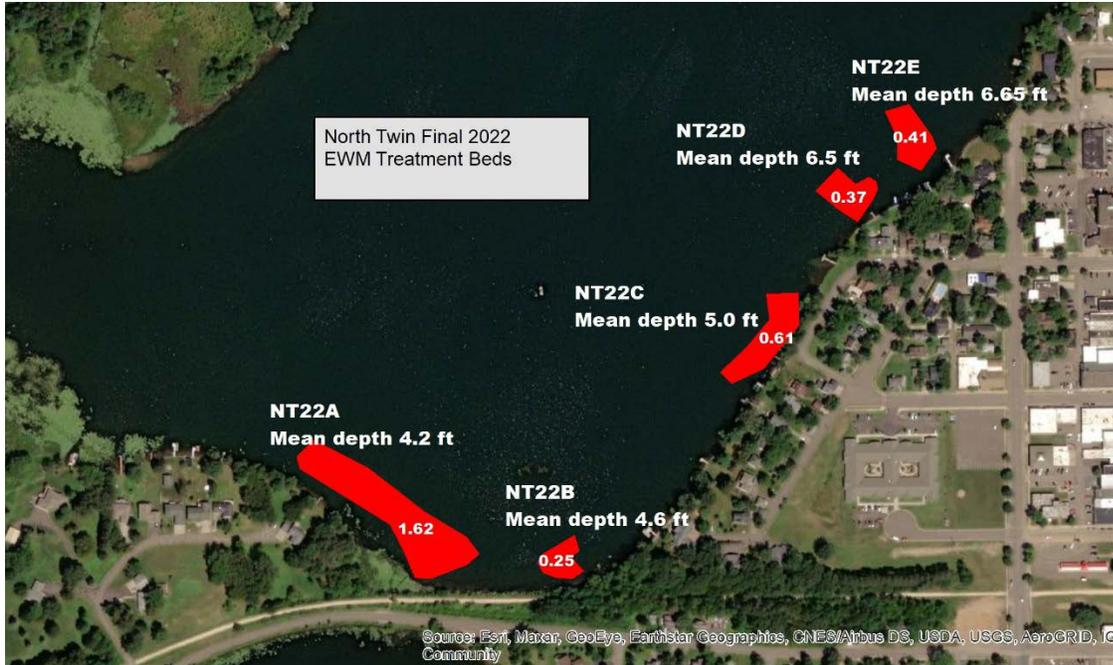
The map on the following page shows the locations and sizes of the various treatment beds.

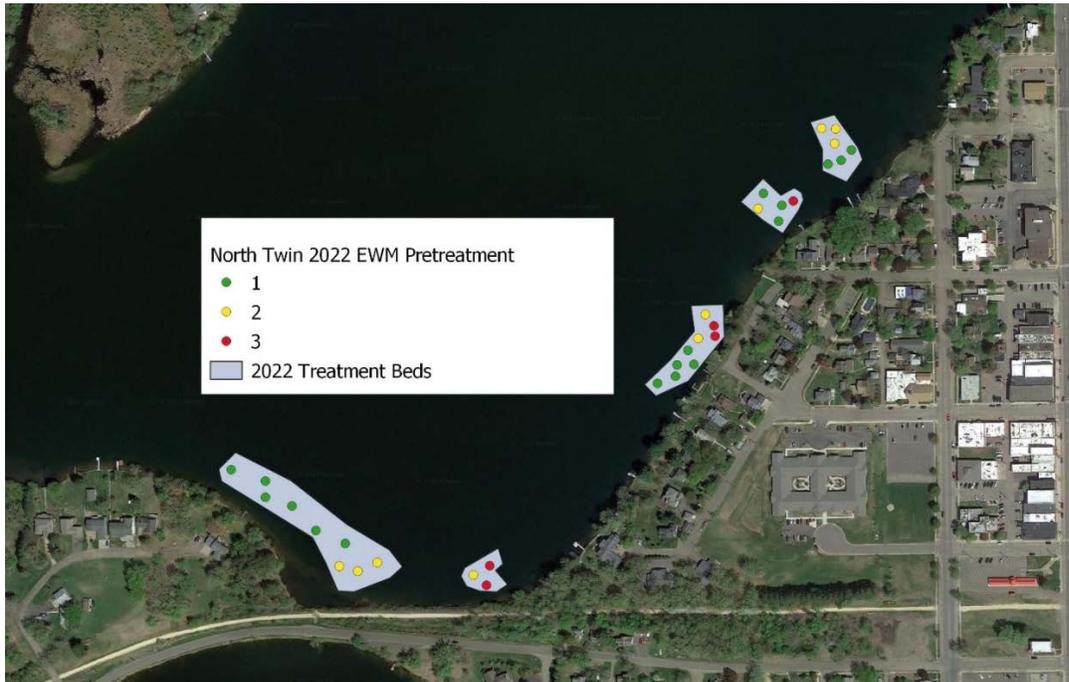
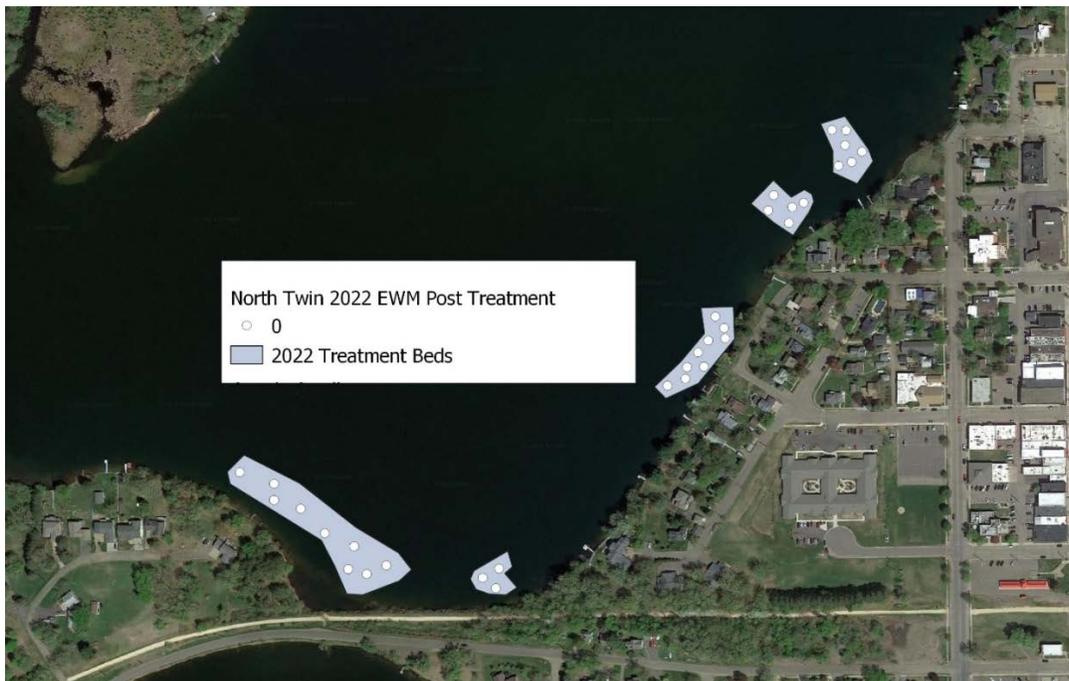
Bed	Pretreatment frequency	Post-treatment frequency	Change/significant?	P-value (from chi-square)
NT22A	100%	0%	Decrease/yes	2.0×10^{-5}
NT22B	100%	0%	Decrease/yes	0.014 (small sample)
NT22C	100%	0%	Decrease/yes	2.0×10^{-5}
NT22D	100%	0%	Decrease/yes	0.002
NT22E	100%	0%	Decrease/yes	0.0005
All beds	100%	0%	Decrease/yes	1.2×10^{-15}

The following maps show the rake fullness of EWM within each treatment bed. The first map is before treatment (August 2021), and the second is after treatment (August 2022).
